CONTOURS OF COUNTRY

Engineering Evaluation Certificate

Reaction to fire test report

Product: DecorZen – FR MDF, AP250S profile, 8 mm perforation, Tasmanian Oak veneer

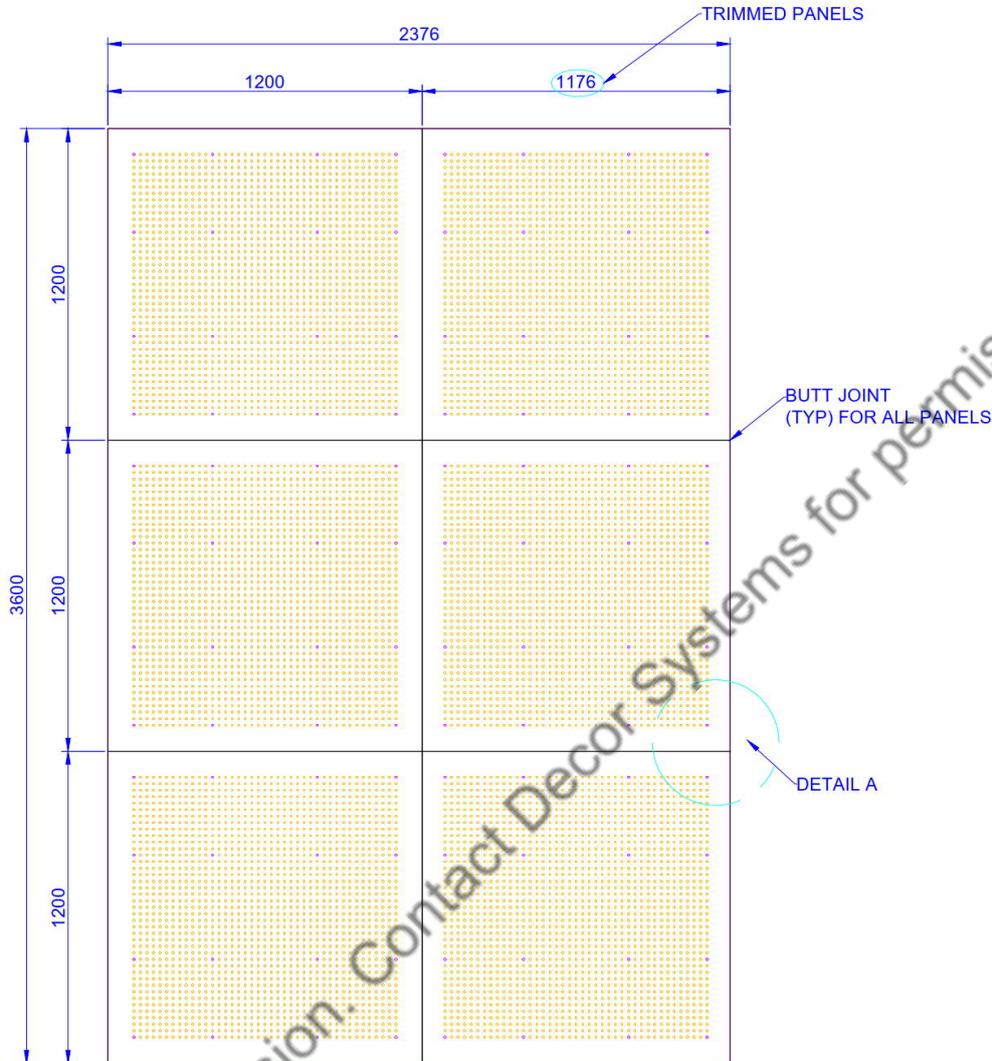
Figure 1 Ceiling panel layout

The drawings of the test assembly were provided by the test sponsor. All measurements – unless indicated – are in millimetres.

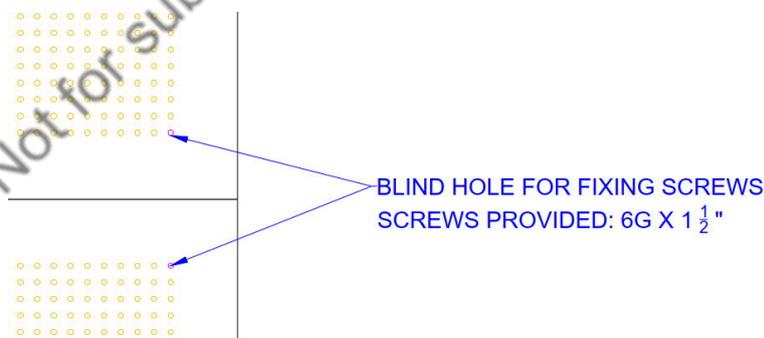
Figure 2 Detail A – panel fixing points

2.	Item name	8G x 65 mm fine thread plasterboard screw – Galvanised steel
Installation method		
The panels were screw fixed at 12 fixing points per panel, as per detailed in the drawing, to the internal plasterboard lining of the fire test room using item 2. The wall panels were installed first, followed by the ceiling panels.

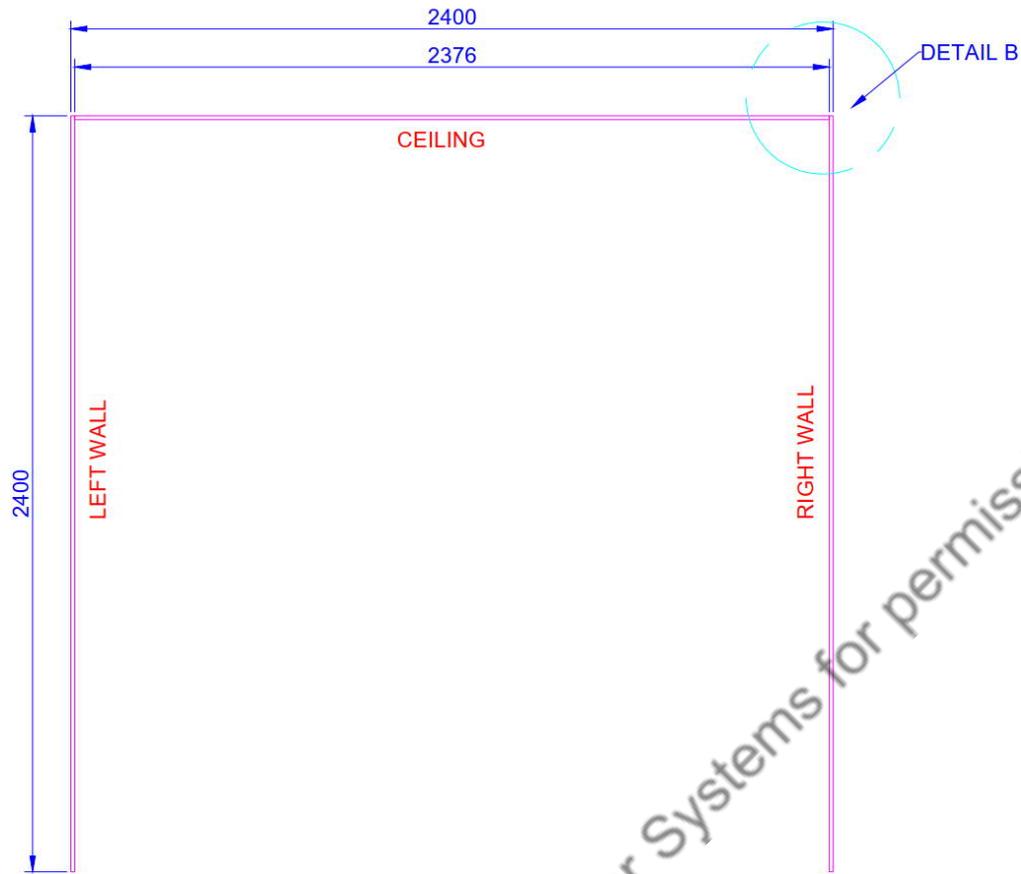
Figure 3 Front view – Ceiling and wall panel layout

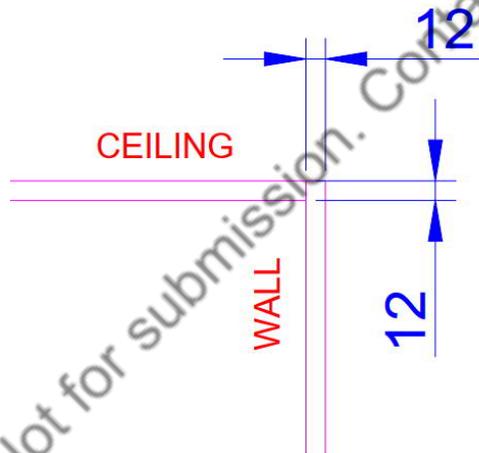
Figure 4 Detail B – Ceiling to wall corner join

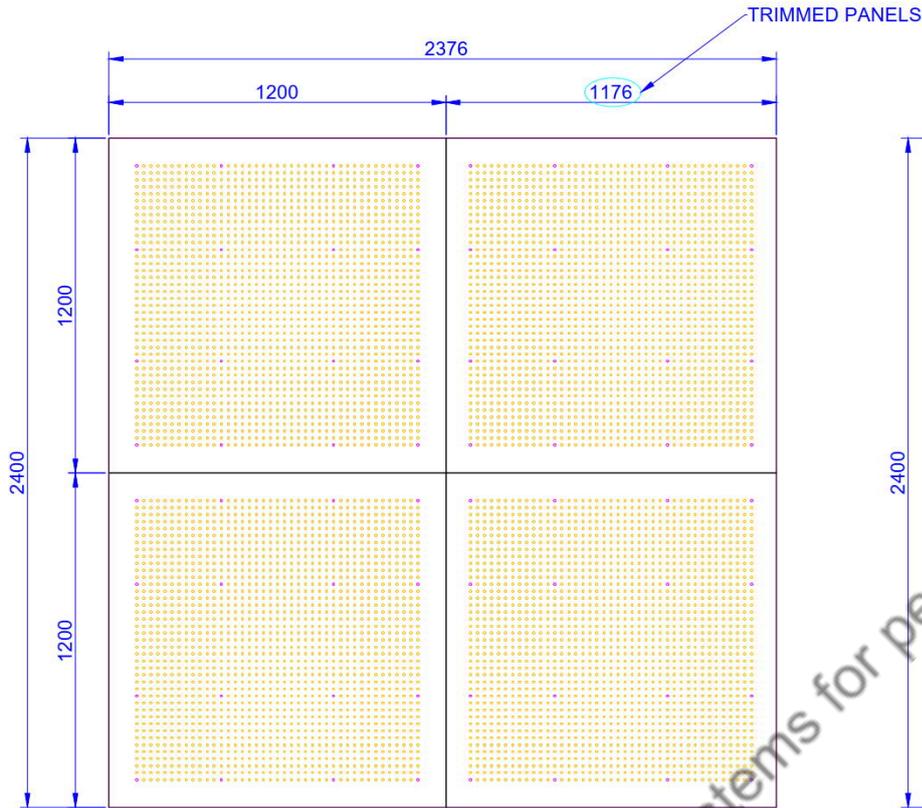
Figure 5 Back wall panel layout

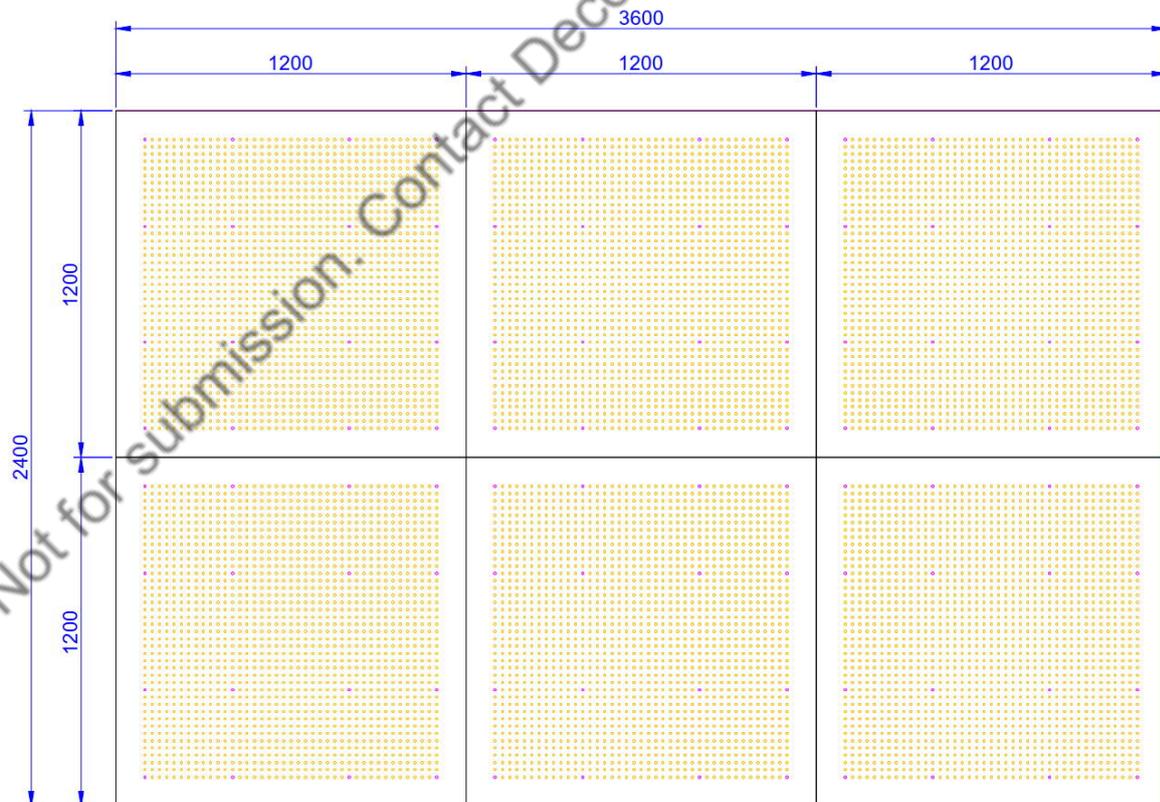
Figure 6 Right wall panel layout

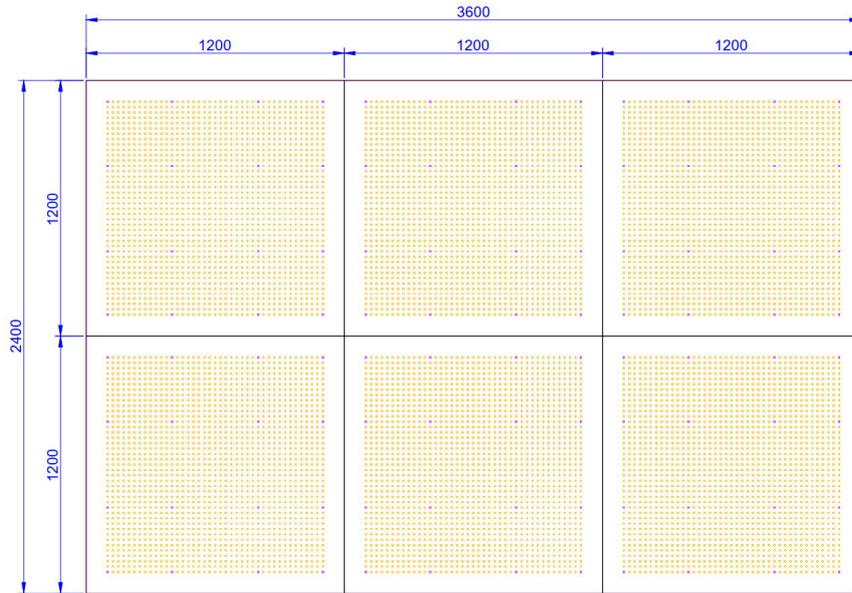
Figure 7 Left wall panel layout

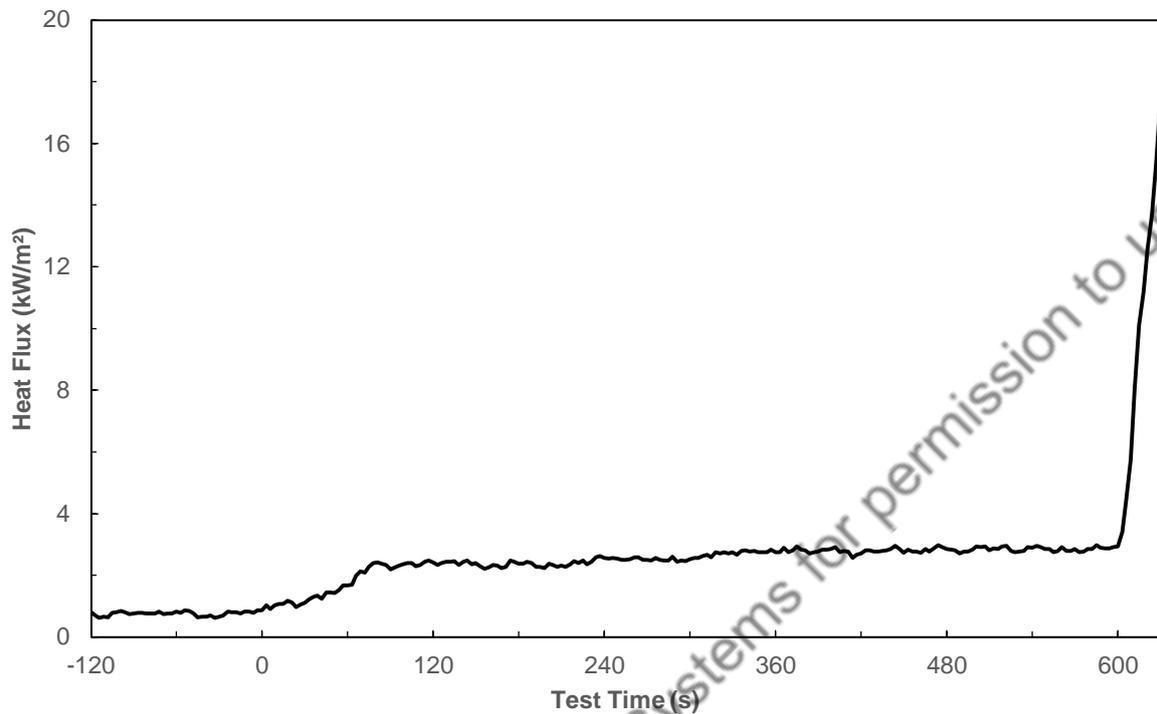
Figure 8 Heat flux vs time

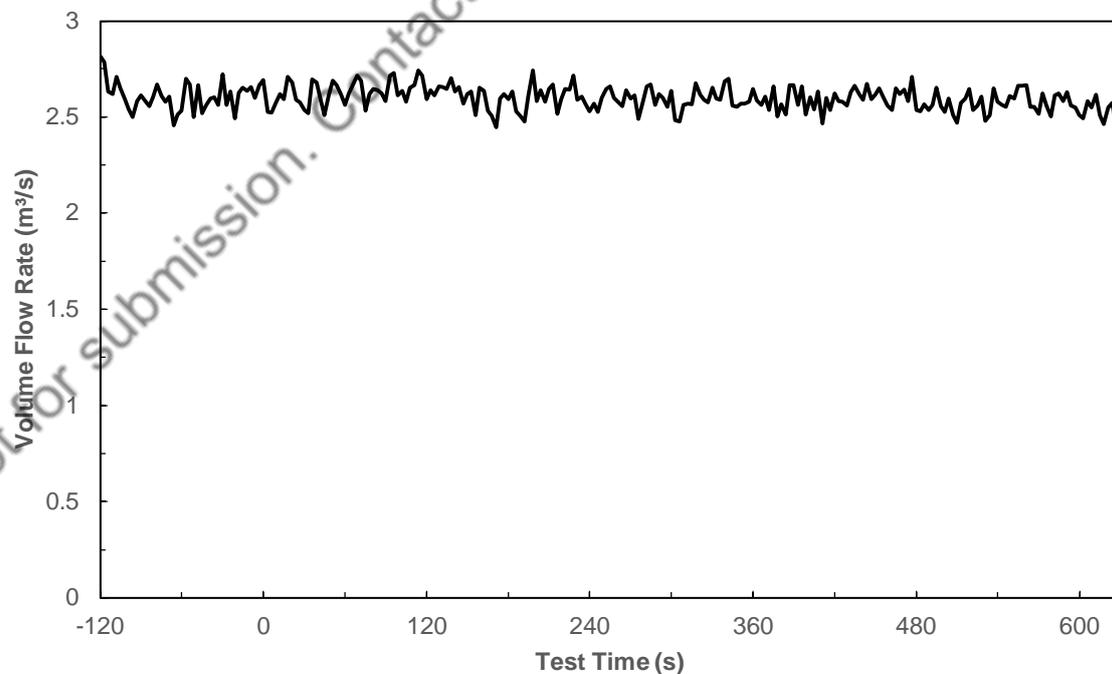
Figure 9 Volume flow rate in duct vs time

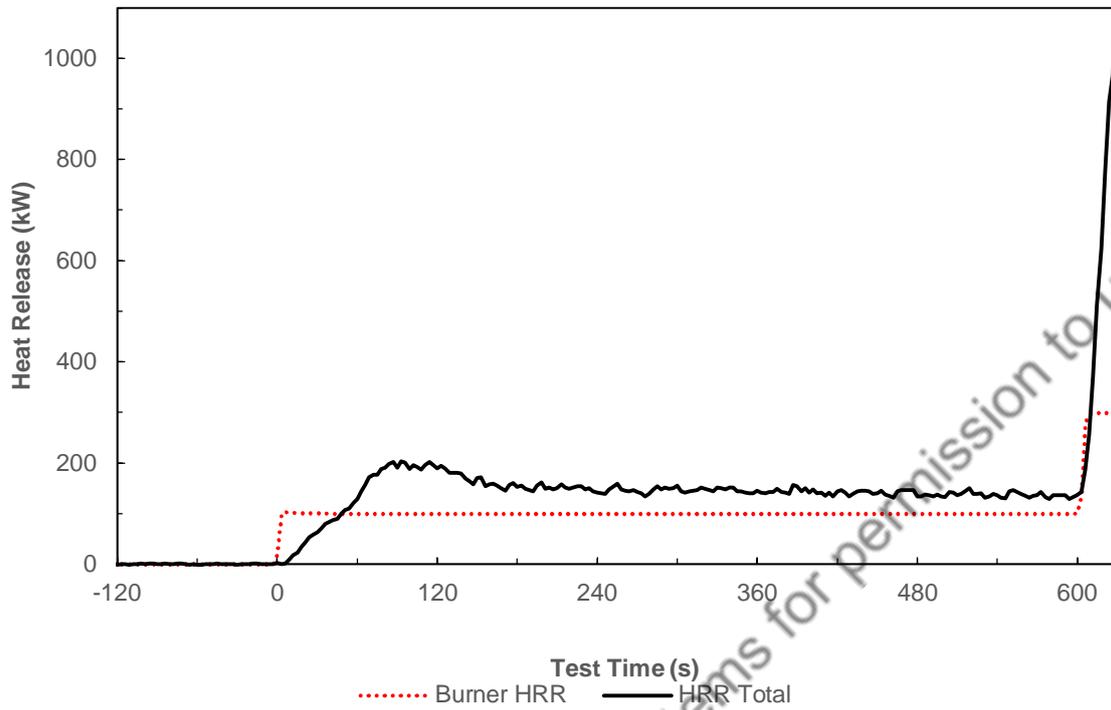
Figure 10 Heat release rate (HRR) of specimen and burner vs time

The material subjected to this AS ISO 9705:2003 (R2016) test achieved a heat release rate of 1 MW after 600 seconds exposure to a 100 kW heat source, immediately followed by a further 30 seconds exposure to a 300 kW heat source. Therefore, the system has achieved a classification of Group 2.

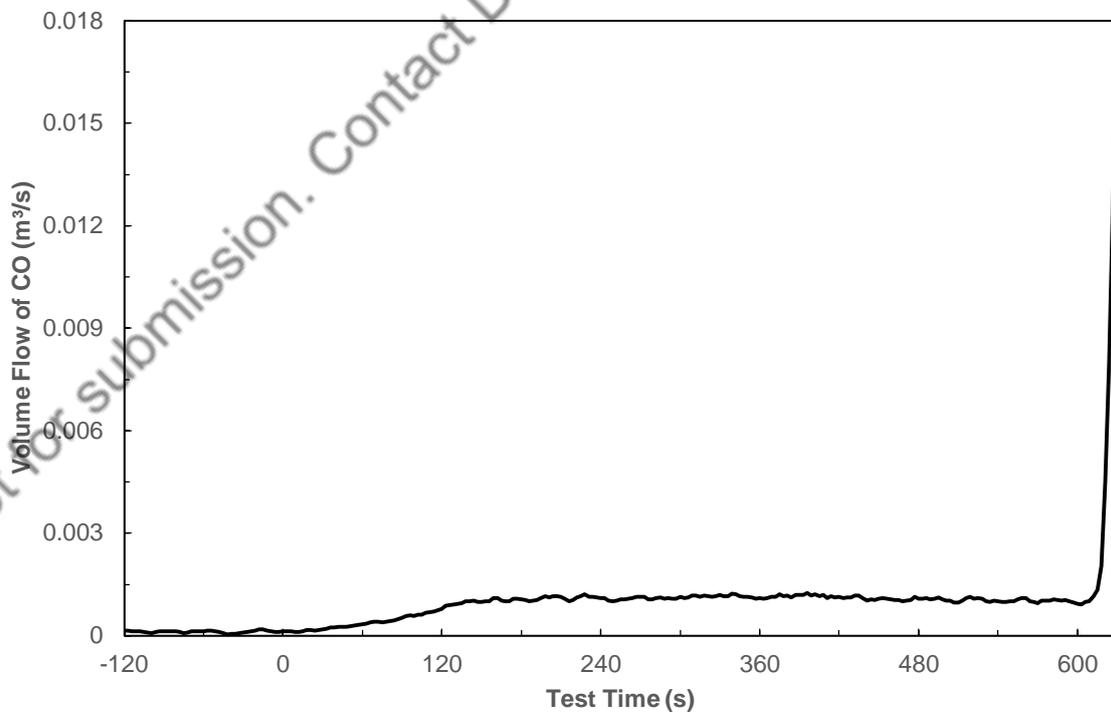
Figure 11 Production of carbon monoxide vs time, at reference temperature and pressure

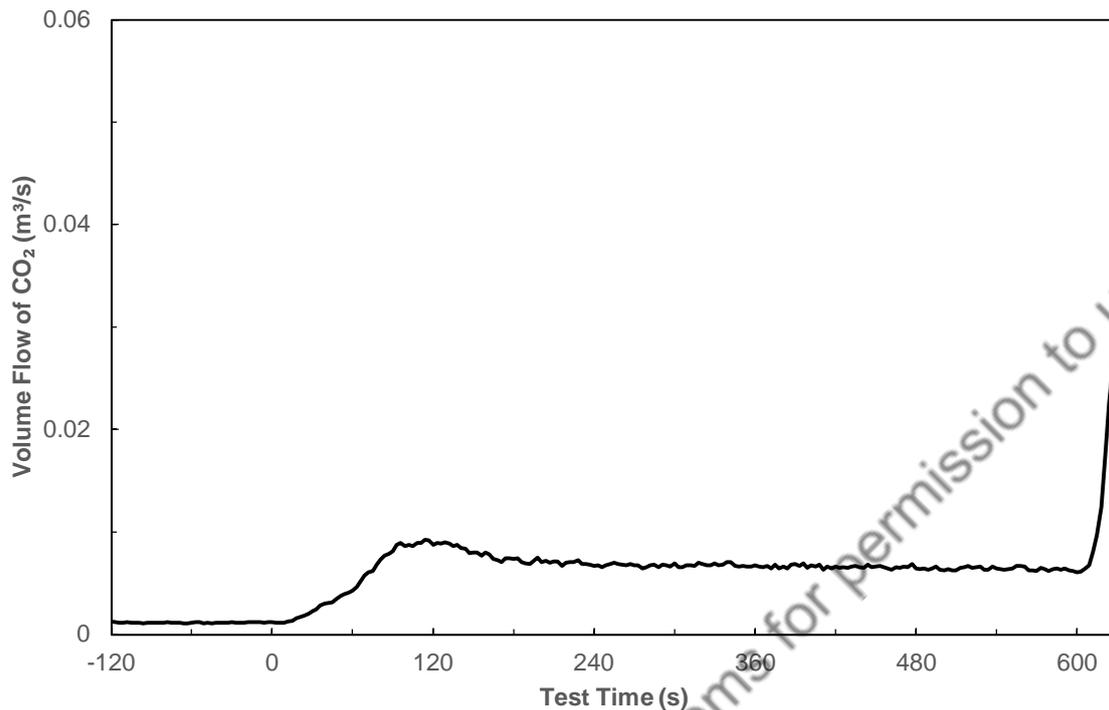
Figure 12 Production of carbon dioxide vs time, at reference temperature and pressure

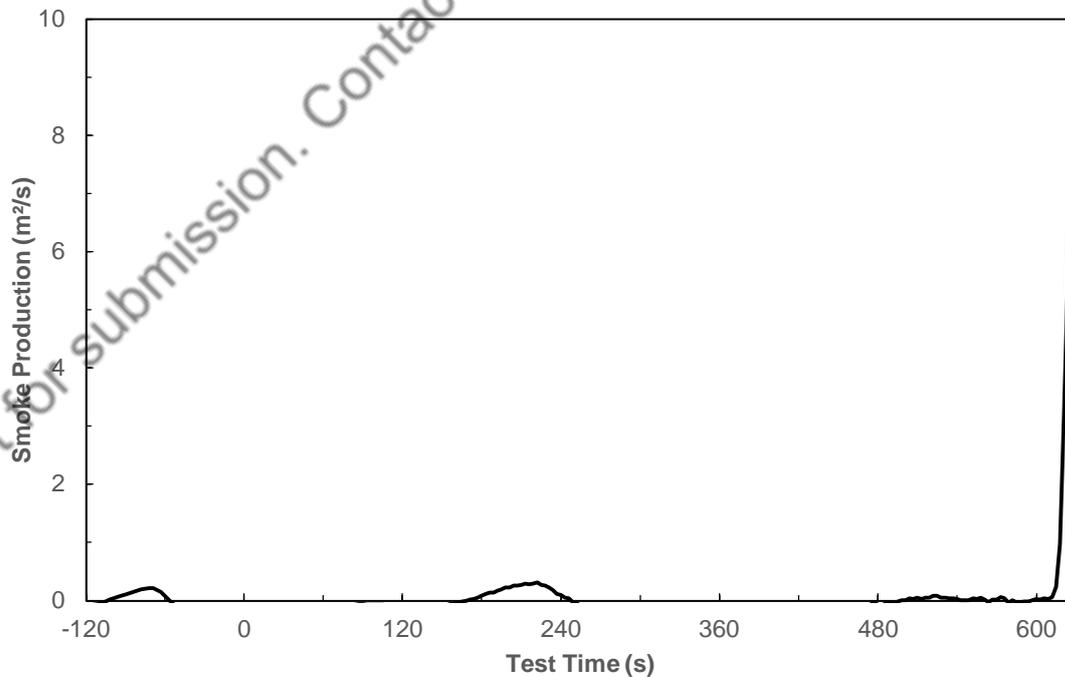
Figure 13 Production of light obscuring smoke vs time, at reference temperature and pressure

The maximum average rate of smoke growth for this material occurred at 600 seconds into the test and was found to be 1.6 m²/s. Therefore, the SMOGRA_{RC} (in m²/s² × 1000) value for the material is 2.7.

The material subjected to this AS ISO 9705:2003 (R2016) test achieved a heat release rate of 1 MW after 600 seconds of exposure to 100 kW, followed by 30 seconds of exposure to 300 kW. Between 0 and 10 minutes of the test period, the average smoke production rate was 0.4 m²/s. Therefore, the C/VM2 – Verification Method: Framework for Fire Safety Design – classifies this material as Group 2 – S.

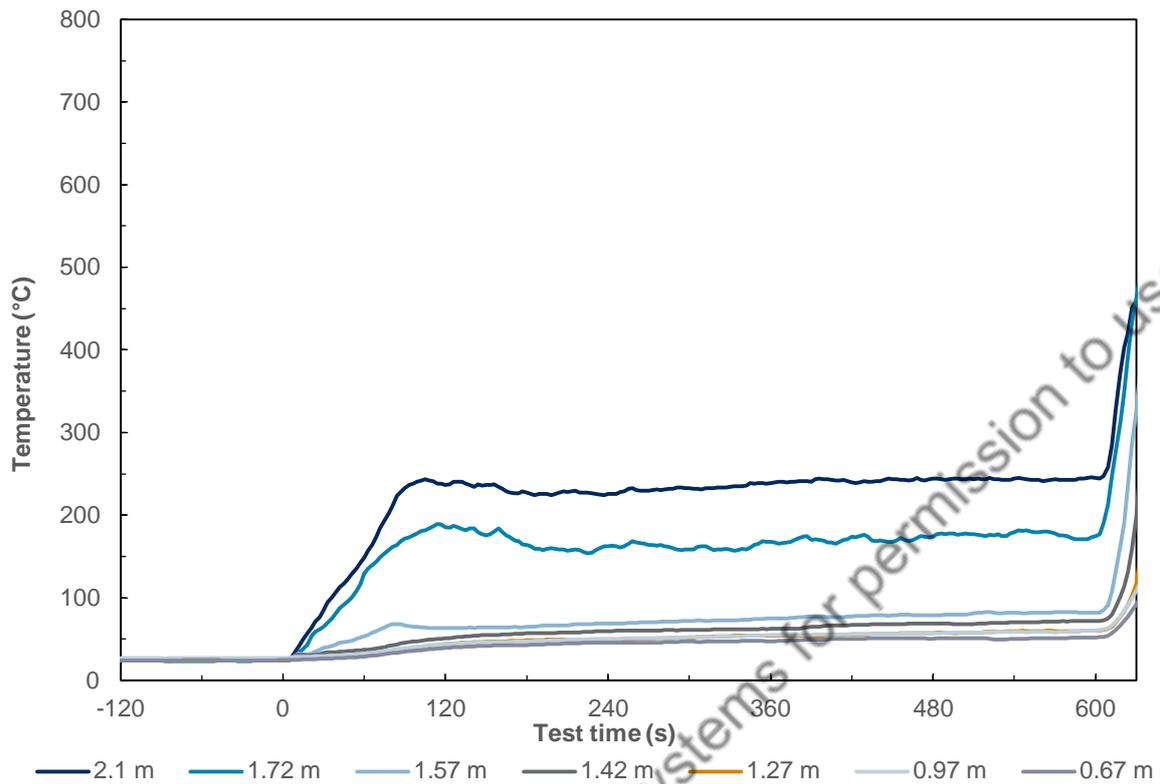
Figure 14 Temperature at the measured heights (from the floor) in the corner opposite to the burner vs time

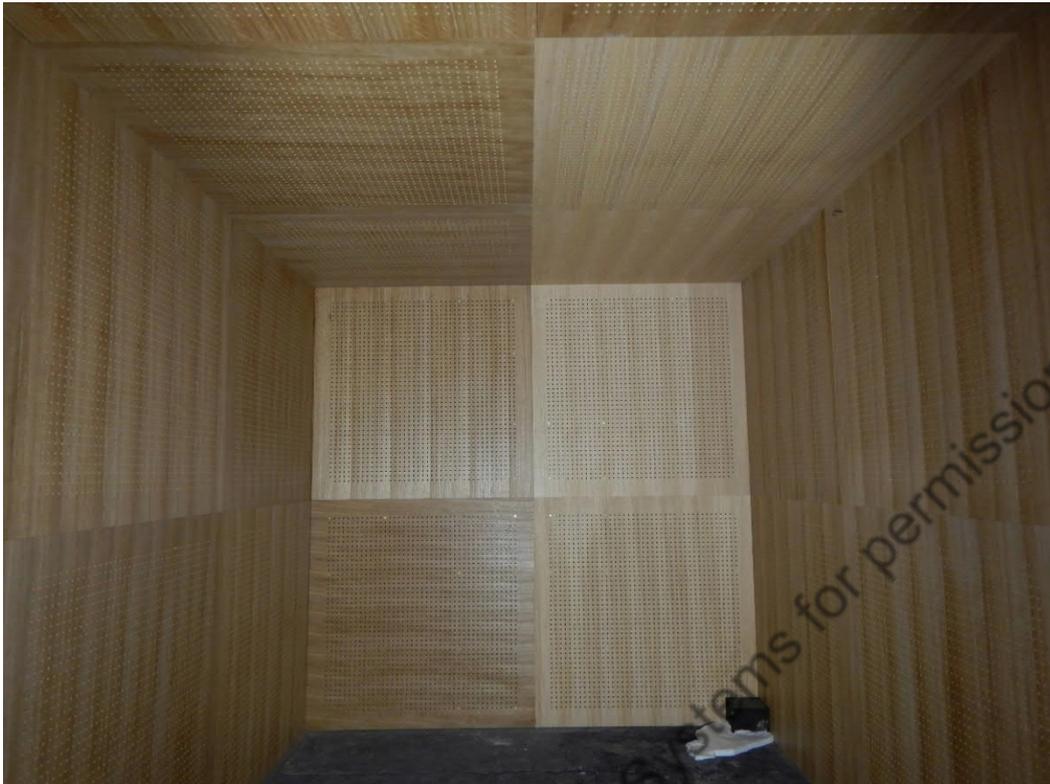
Figure 15 The specimen before the reaction to fire test

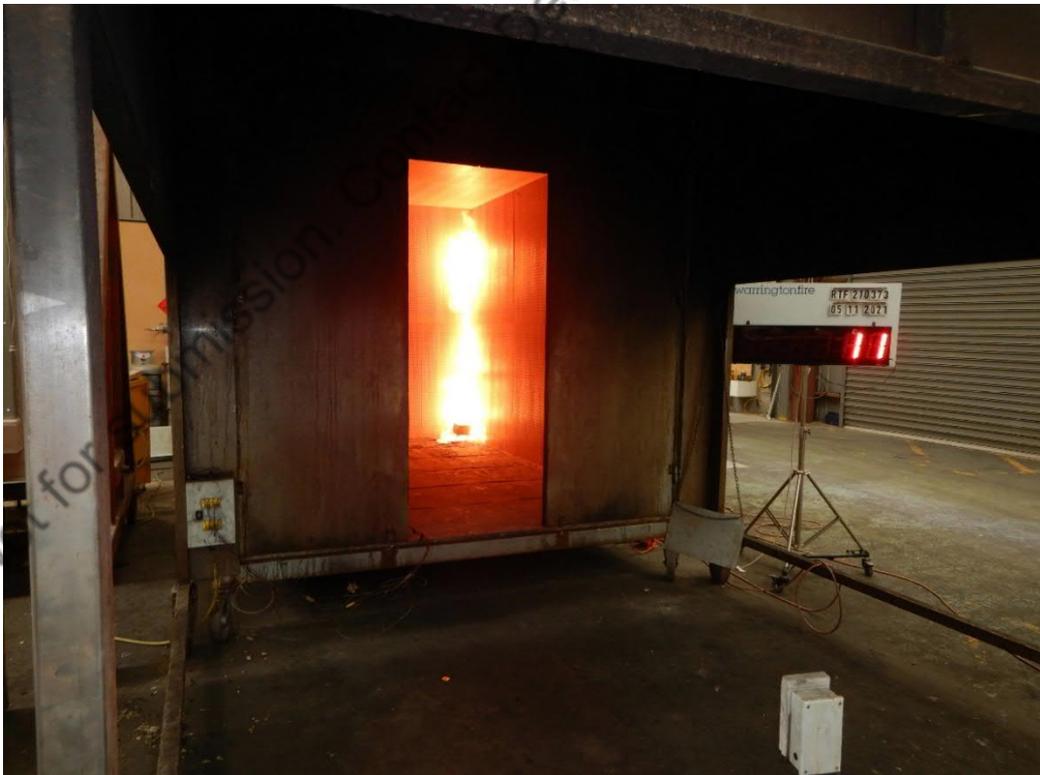
Figure 16 The specimen 11 seconds after burner ignition with the burner output of 100 kW

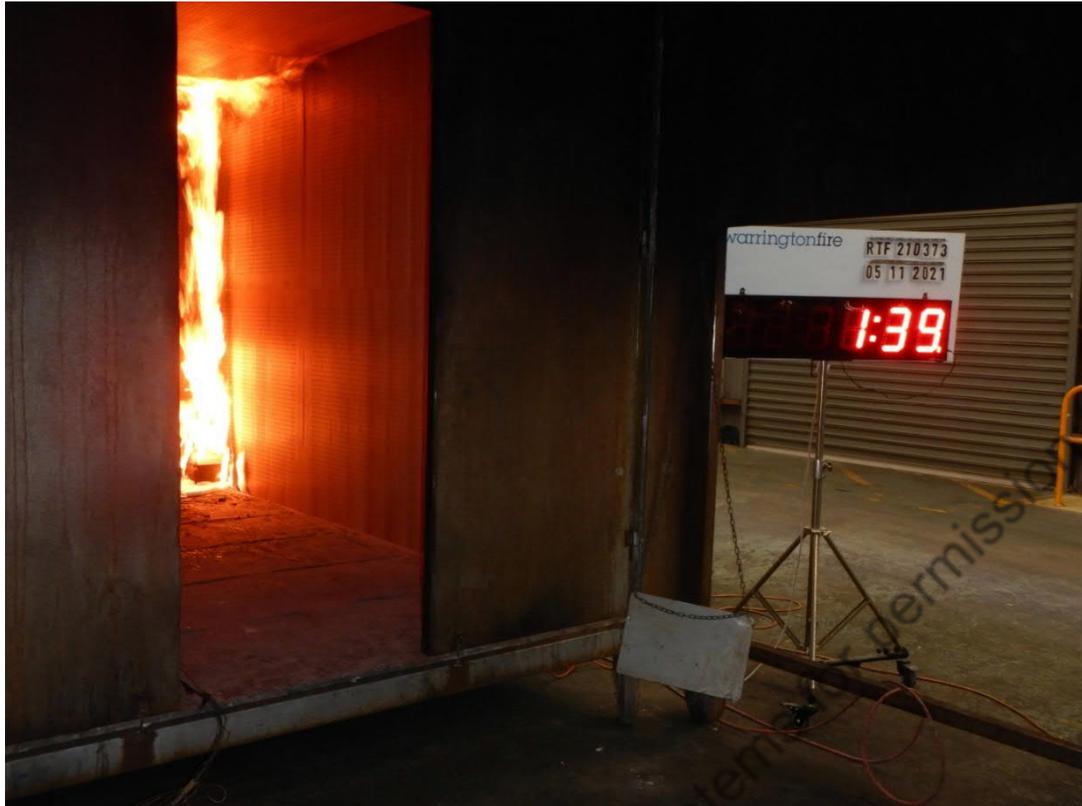
Figure 17 The specimen 1 minute 39 seconds after burner ignition with the burner output of 100 kW

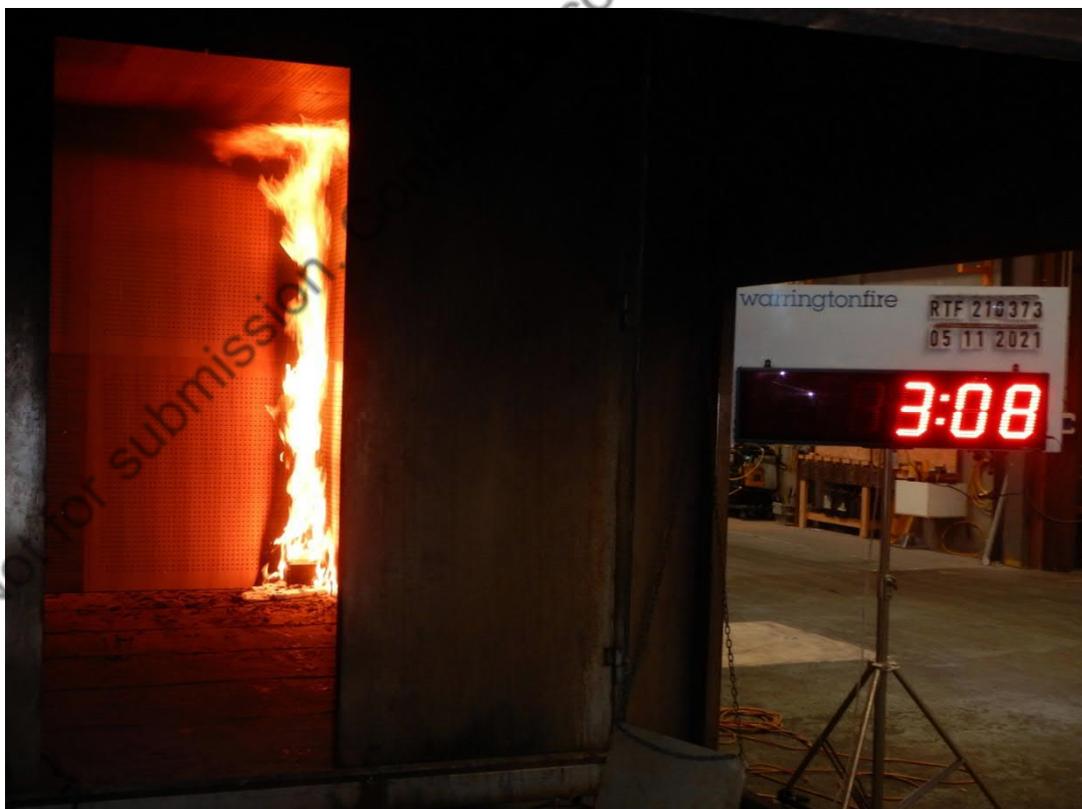
Figure 18 The specimen 3 minutes 8 seconds after burner ignition with the burner output of 100 kW

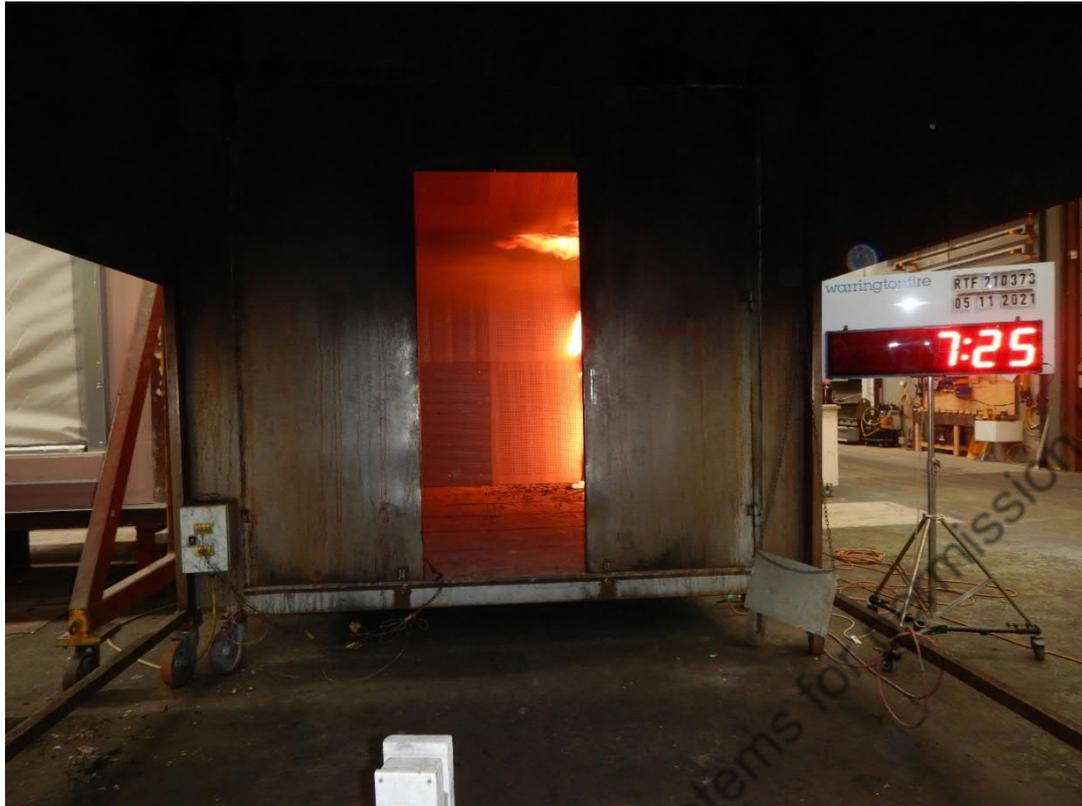
Figure 19 The specimen 7 minutes 25 seconds after burner ignition with the burner output of 100 kW

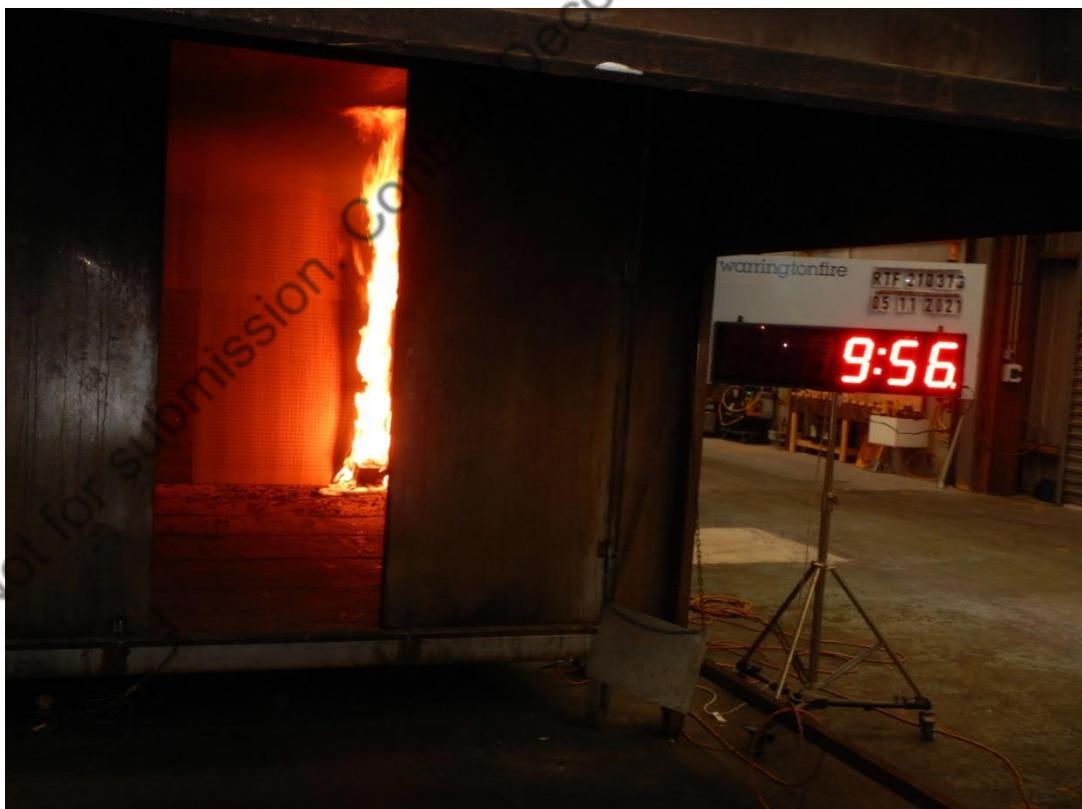
Figure 20 The specimen 9 minutes 56 seconds after burner ignition with the burner output of 100 kW

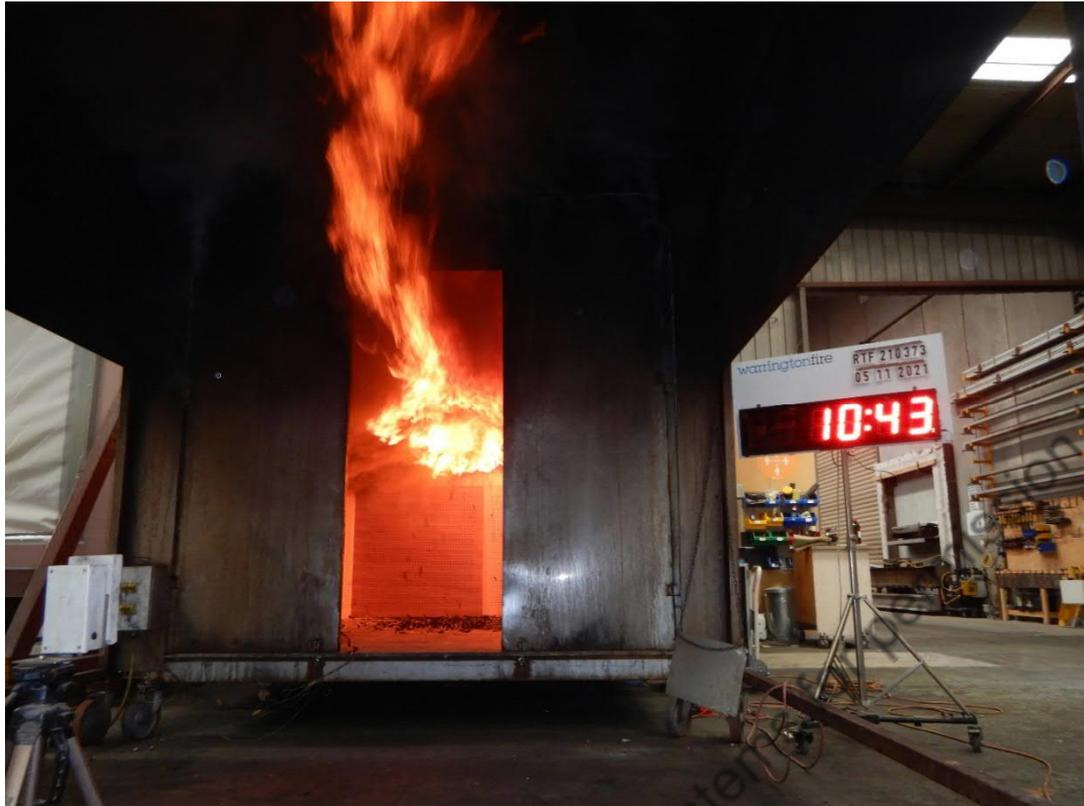
Figure 21 The specimen after flashover (43 seconds after burner output was increased to 300 kW)

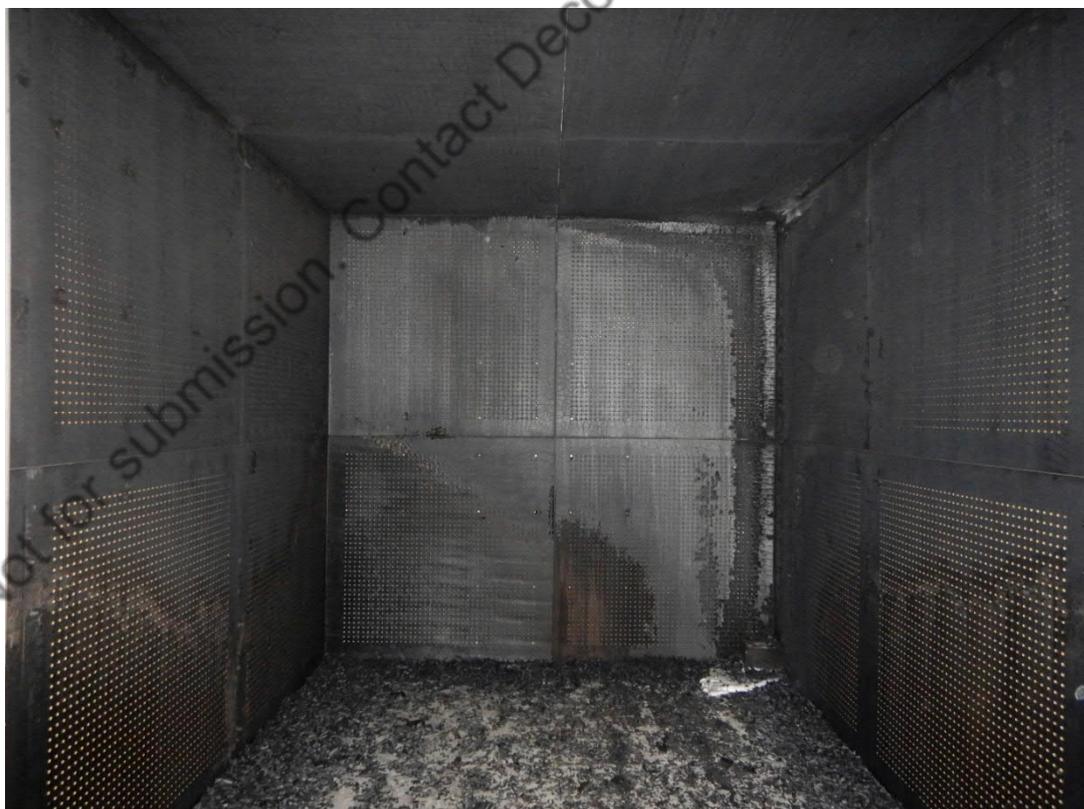
Figure 22 The specimen after the reaction to fire test
