SIKA AT WORK

PROSPECT RESERVOIR, JOINT REFURBISHMENT

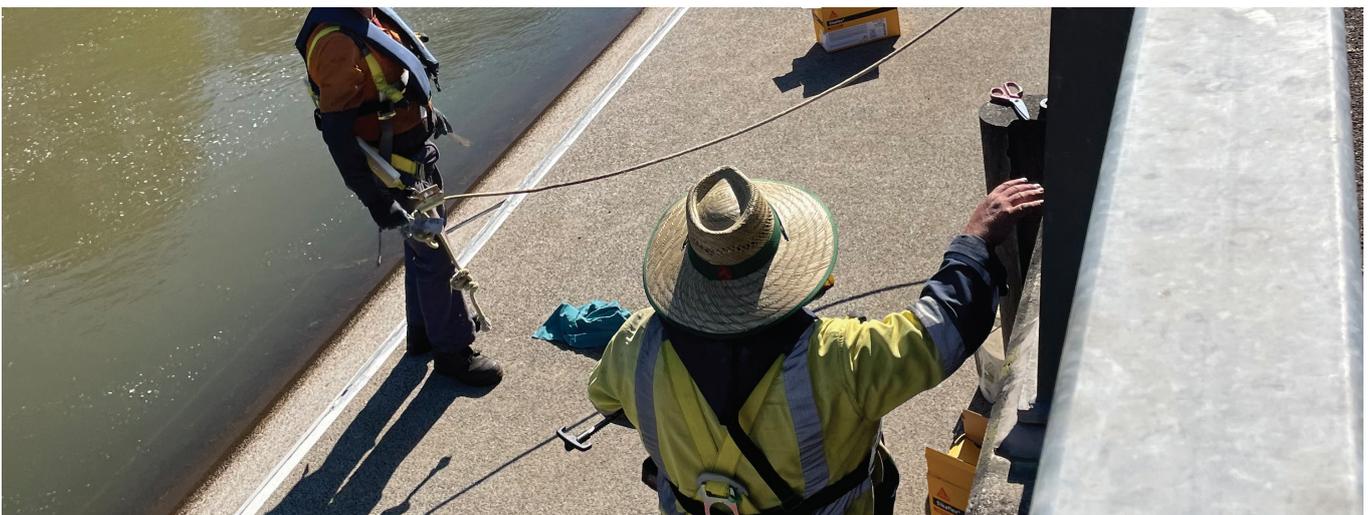
The area shown below will have live water flow across the weir from the reservoir into the water channel when in use. Sika was specified by the consulting engineer, Arup, in this instance the solution was selected with technical support and guidance from the Sika specification team. The design solution for these emergency repairs included a full Sika system for joint repairs above and below the water line.

Above the water line application: Removal of existing failed sealant from unknown source. Preparation and cleaning of the joint surface and application of Sikaflex® PRO-3 Purform®. The Sikaflex® PRO-3 Purform® joint will be later covered with Combiflex SG system, EPDM rubber and mechanically fixed steel cover plate. Underwater joints will be treated separately with Sika injection systems.

Below the water line application: This joint was required to be waterproof to prevent water ingress to the below substructure and it was necessary to apply the solution while the joint was fully immersed under the water. A cover plate was applied to allow the injection application of Sika® Injection-111 directly into the joint, the expanding urethane foam filled the joint and displaced the water. A second injection layer using Sika® Injection-306 acrylate resin provided the final seal of all voids to form a waterproof joint.
